## Aviation Safety

# Vortex

Learn from the mistakes of others; you'll not live long enough to make them all yourself . . . Issue 3/2000

## Accidents Never Change—Only People Change

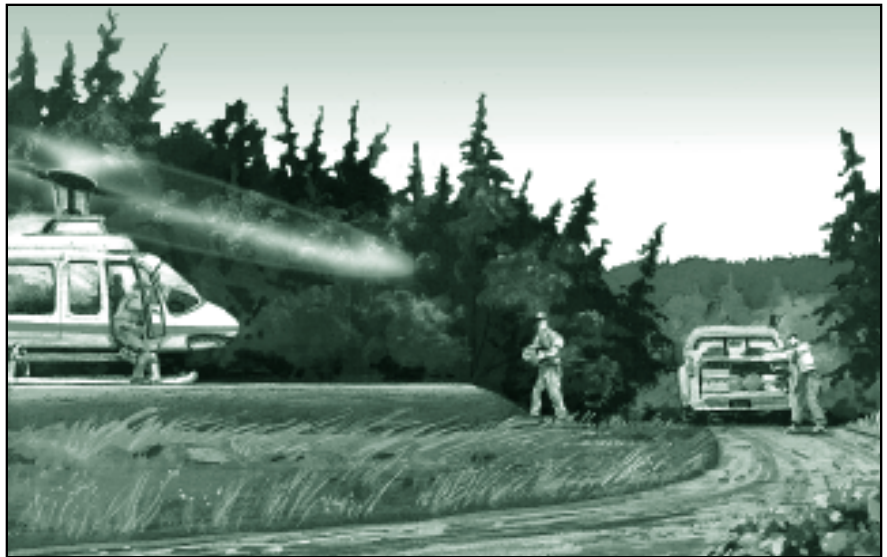
removed before the flight could commence. The mechanic was unfamiliar with the 407, so the pilot went back to the helicopter with him to explain the door removal procedure. The pilot then returned to the truck as the mechanic started to remove the door.

First the nuts for the hinge bolts were removed, followed by the lower bolt of the door closer air spring. Then the hinge bolts were removed, and the door, with the door closer air spring attached, was removed and carried away from the helicopter by the mechanic.

slung load. As the pilot approached, he was struck in the head by the rotor tip and he fell to the ground, dead.

With the hydraulic system on and the cyclic friction set at about the midpoint (the way it was found after the accident), the cyclic position could be displaced forward and to the left during door removal with minimal effort. Left forward movement of the cyclic would lower the disk in the exact area the pilot approached from.
